## LuK Service Info

# Error message: Clutch slipping

Manufacturer: Mercedes Benz

Model: Actros

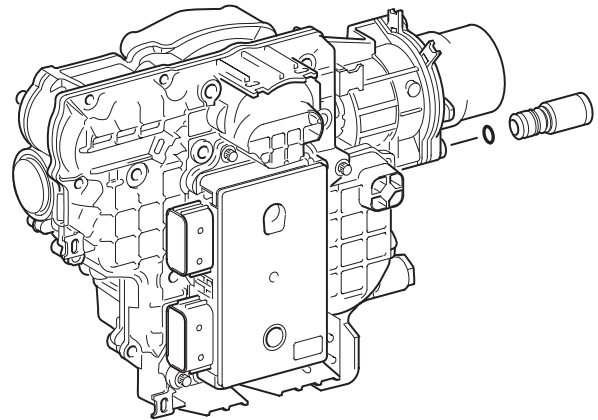
Image 1: The breather valve must be removed when the clutch actuator is installed

- The connecting line of the clutch actuator has not been properly secured in the clutch bell housing and has been worn through by the flywheel during operation
- The breather valve (image 1) was not removed when the clutch actuator was installed. The lack of ventilation has damaged the clutch actuator during installation of the transmission
- When installing the clutch actuator, the seal (image 2) was destroyed
- Moisture has penetrated the electrical connection between the clutch actuator and the control unit (e.g. due to use of a high-pressure cleaner)

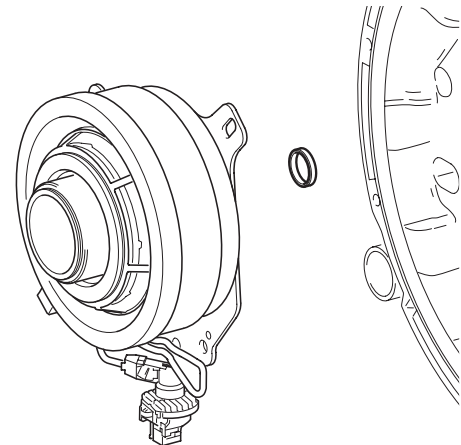
Image 2: When installing the clutch actuator, be careful not to destroy the seal
